INDOOR AIR QUALITY ASSESSMENT

**Mass Commission for the Blind and
Mass Commission for the Deaf and Hard of Hearing
600 Washington Street, 3rd Floor, Boston, MA**

Prepared by:
Massachusetts Department of Public Health
Bureau of Environmental Health
Indoor Air Quality Program
November 2017

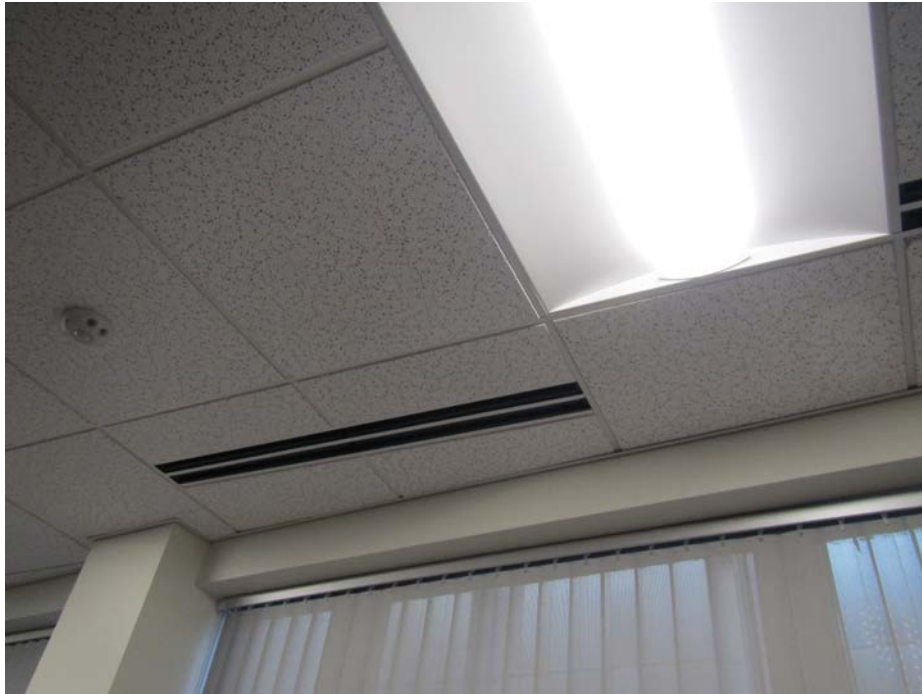
Picture 1

Fresh air is supplied by air handling units and delivered to supply vents located in the ceilings of rooms (Pictures 1 and 2). Return air is drawn through grates using a plenum return (Picture 3). In some areas, such as bathrooms, directly-vented exhausts are present (Picture 4). Note that although supply and return vents are present in open areas, some offices consist of tall partitions that almost reach the ceiling (Picture 5) and not all of these areas have both a supply and return vent near the top. This configuration may make distribution of fresh air, removal of stale air, and temperature control more difficult especially when doors are closed.

Supply vent along windows

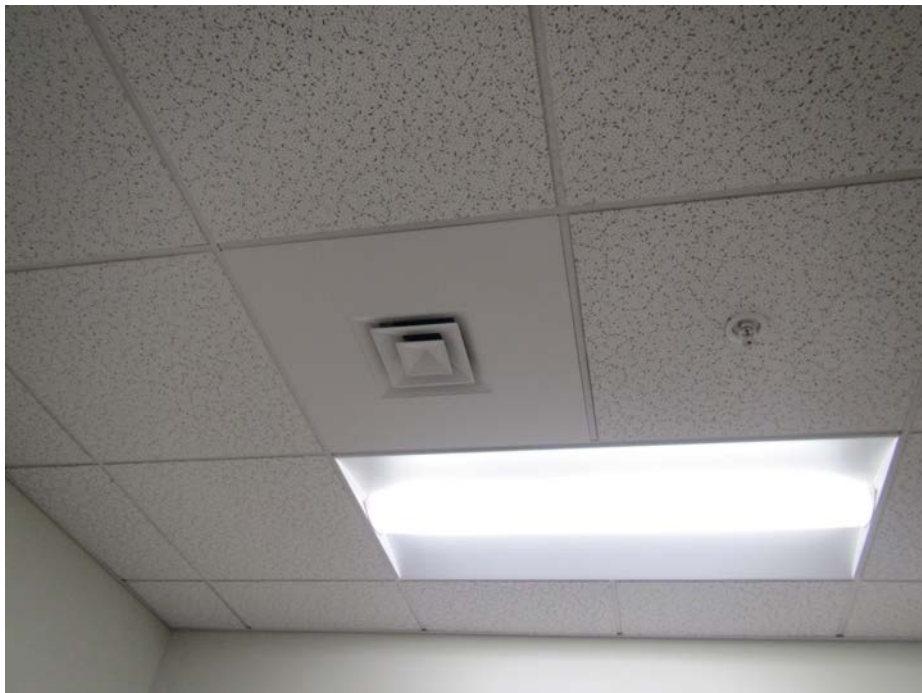
Picture 2

Supply vent

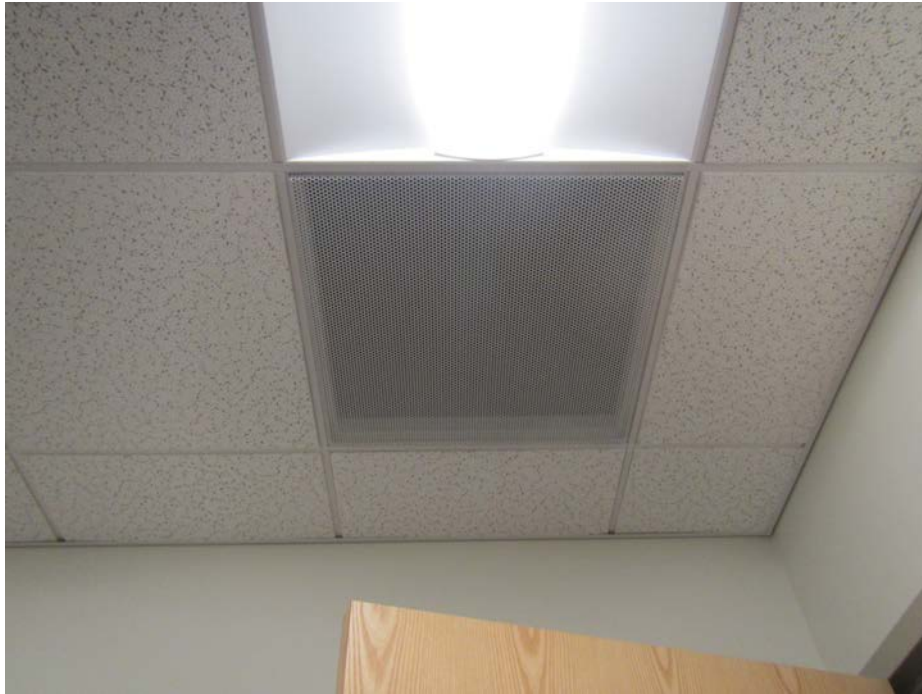
Picture 3

Typical plenum return grill

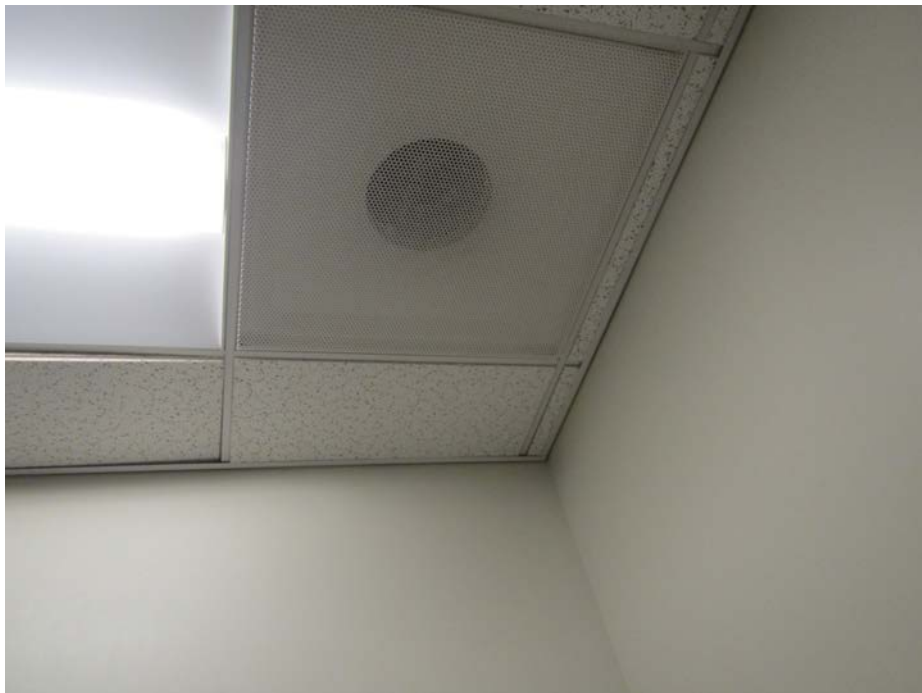
Picture 4

Direct vented exhaust vent

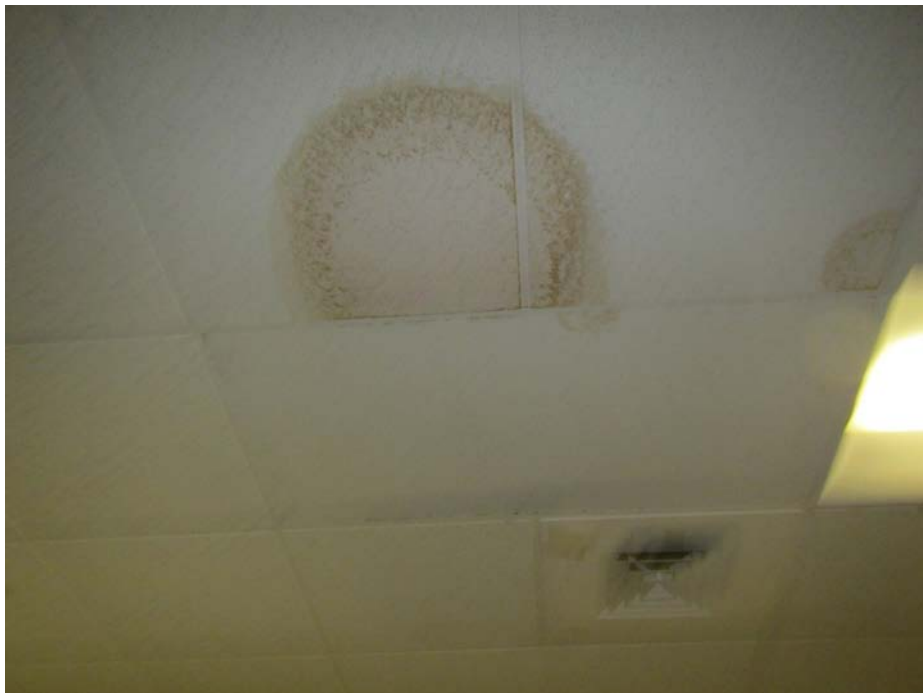
Picture 6

A few water-damaged ceiling tiles were observed (Pictures 5 and 6). These likely originate with plumbing or HVAC system leaks. Stained tiles should be replaced after a leak is repaired.

Water-damaged ceiling tile

5. Repair plumbing/HVAC leaks and replace water-damaged ceiling tiles.
6. Monitor windows for leakage in areas which appear damaged. Report damaged windows to maintenance.

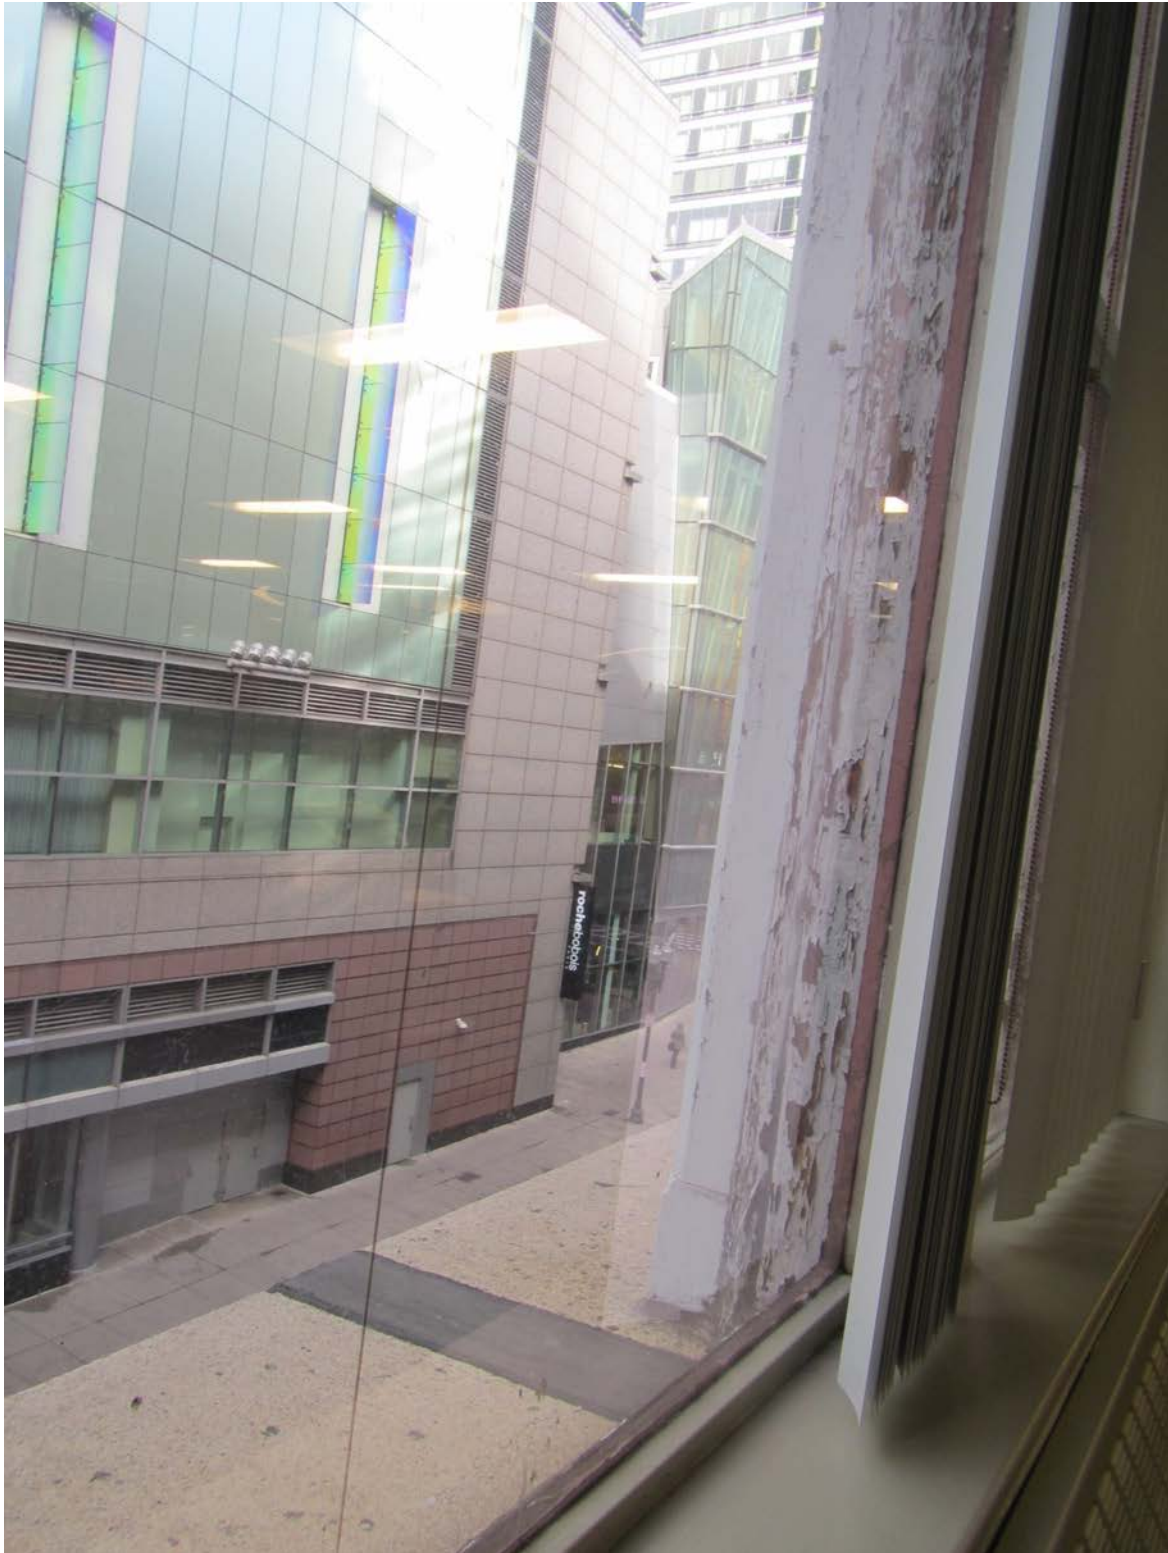
Picture 7

Note that some window frames had peeling paint and were otherwise in poor condition, mostly on the outside of the building (Picture 7). No water infiltration was noted or reported, however continued deterioration of window frames can lead to leaks inside.

Peeling paint on exterior of window frame

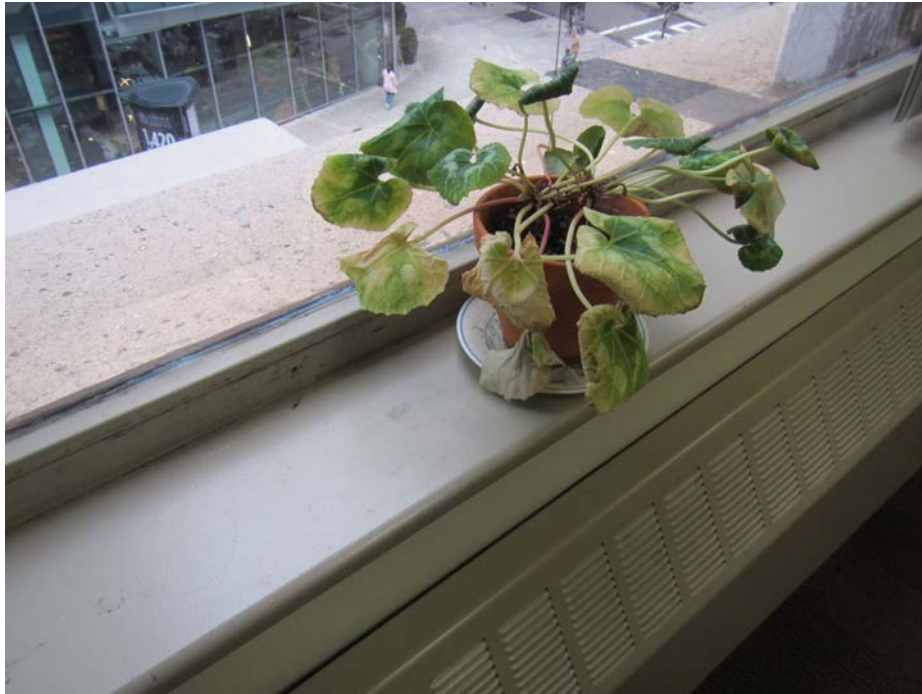
Picture 8

Plants were observed in some offices and cubicles (Pictures 8 and 9). Some of these plants were in poor condition or located on porous surfaces such as carpet. Plants should be well maintained and not overwatered to prevent odors, water damage, and pests.

Plant in poor condition with porous materials

7. Keep plants in good condition, avoid overwatering, and remove from the airstream of heating and ventilation equipment.
8. Consider the use of waterproof mats underneath all water dispensers and refrigerators to protect carpet. Keep refrigerators clean.

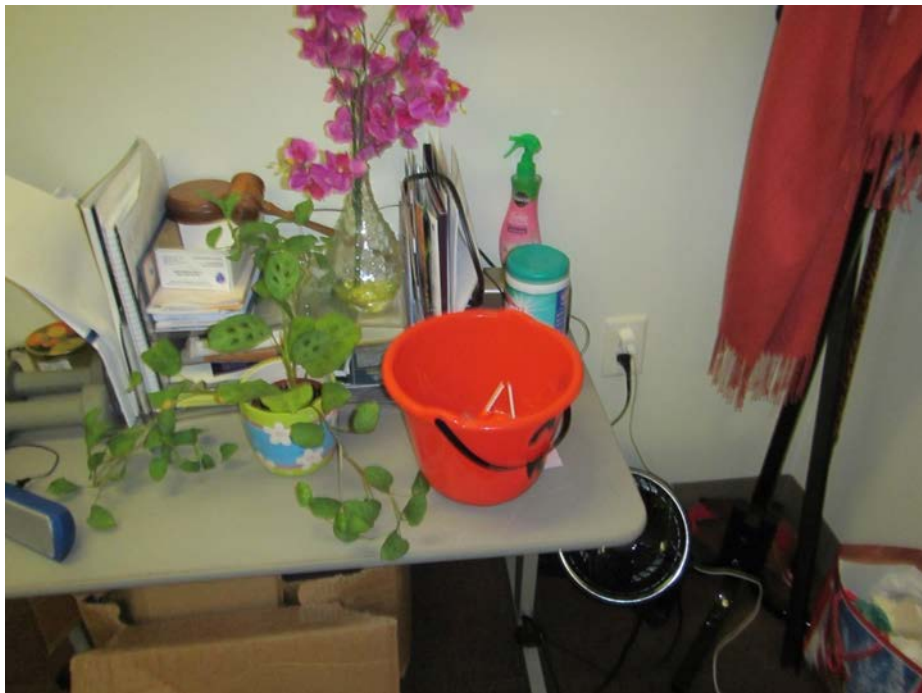
Picture 9

Plant and cleaning materials

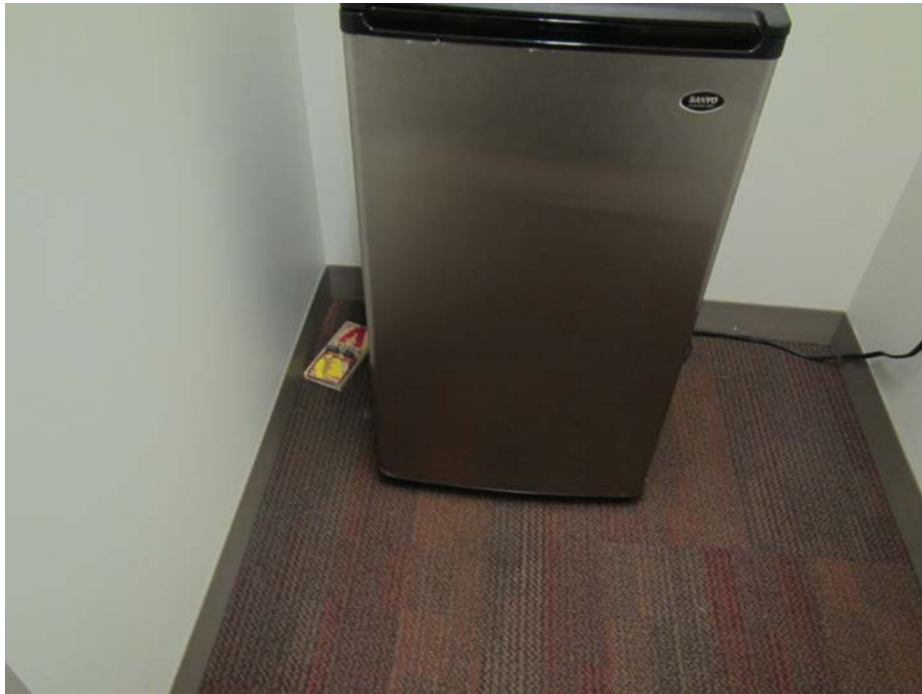
Picture 10

Small refrigerators and water dispensers were observed in carpeted areas (Picture 10; Table 1). These appliances may spill or leak and lead to carpet damage and microbial growth. Many of them were placed on waterproof mats already, and it is recommended others be located in areas without carpeting or on waterproof mats. Refrigerators should be kept clean to prevent odors and microbial growth.

Rodent traps were observed in several areas (Picture 10; Table 1). Rodent infestation can result in IAQ-related symptoms due to materials in their wastes. Mouse urine contains a protein that is a known sensitizer (US EPA, 1992). A sensitizer is a material that can produce symptoms (e.g., running nose or skin rashes) in sensitive individuals after repeated exposure. To eliminate exposure to allergens, rodents must be removed from the building. Please note that removal, even after cleaning, may not provide immediate relief since allergens can exist in the interior for several months after rodents are eliminated (Burge, 1995). Once the infestation is eliminated, a combination of cleaning and increased ventilation and filtration should serve to reduce allergens associated with rodents.

Refrigerator on carpet, also note mousetrap

11. Use the principles of Integrated Pest Management (IPM) and the services of a licensed pest control operator to remove rodents and reduce the potential for pest infestation. Ensure that any area where rodents may have been is thoroughly cleaned to remove allergens.

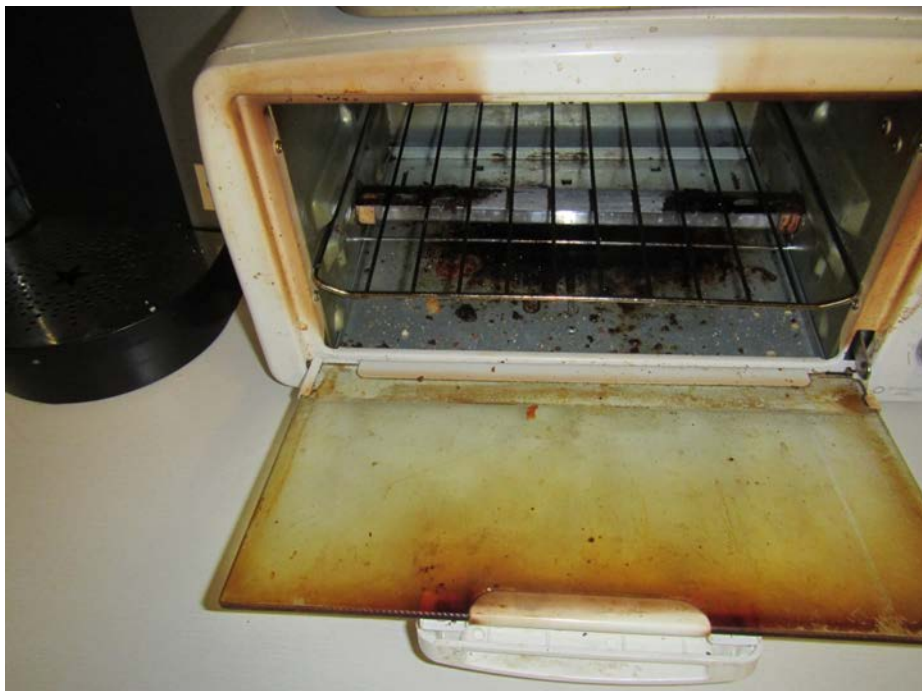
Picture 11

Cooking equipment, including toasters (Picture 11), microwave ovens, and coffee machines, were located in various parts of the office space. Food areas and cooking equipment need to be kept clean to prevent odors and pests.

Toaster with crumbs

9. Reduce the use of cleaning products, sanitizers, and other items that contain VOCs. Minimize the use of scented products.
10. Ensure that all cooking equipment is kept clean.

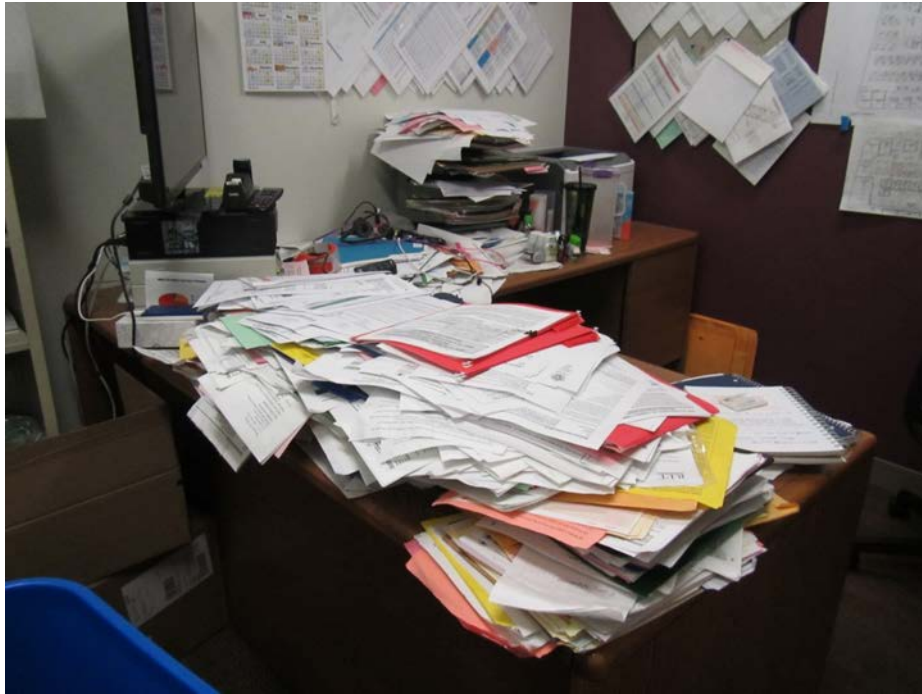
Picture 12

In some areas, stored materials and accumulated items make it more difficult for custodial staff to clean (Picture 12; Table 1). Items should be stored neatly and moved periodically to allow for wet-wiping and vacuuming of surfaces. The configuration of cubicle walls and dividers create some areas that are difficult to access for cleaning, including some that are used for storage of items (Picture 13). Regular examination and cleaning of these areas, including removal of lost items and debris, should be conducted to prevent the areas becoming harborage for pests or a source of odors. Items should also not be stored on top of radiators (e.g., Picture 14) or in the airstream of ventilation equipment as heating and moving air can cause items to release dusts and odors.

Papers on a desk

12. Reduce the amount of items stored on flat surfaces to allow regular cleaning.
13. Ensure that areas between cubicle walls and the exterior wall of the building are monitored for debris and cleaned regularly.

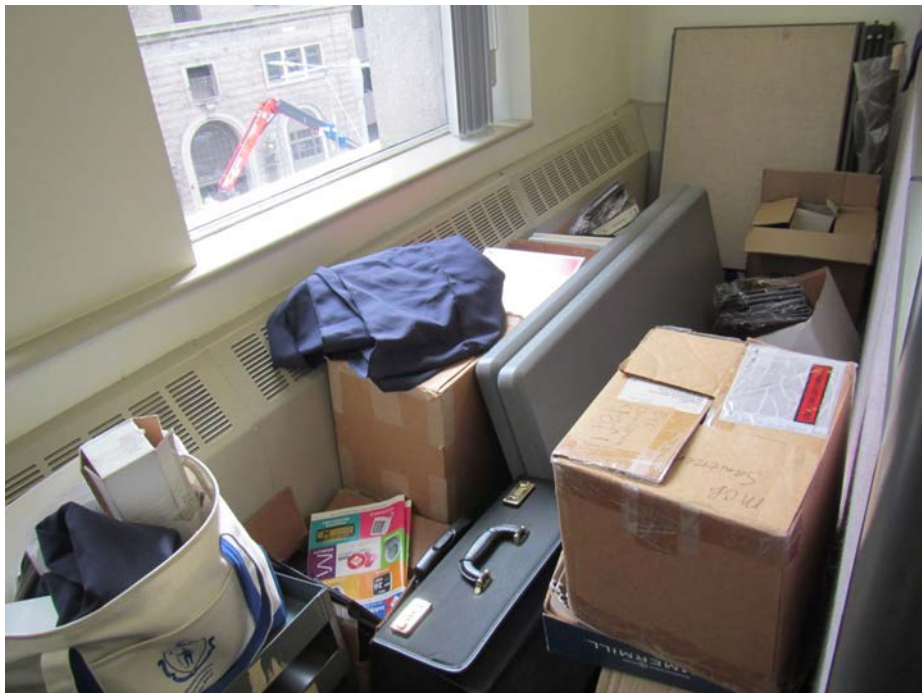
Picture 13

Difficult to access storage area between cubicle dividers and exterior wall

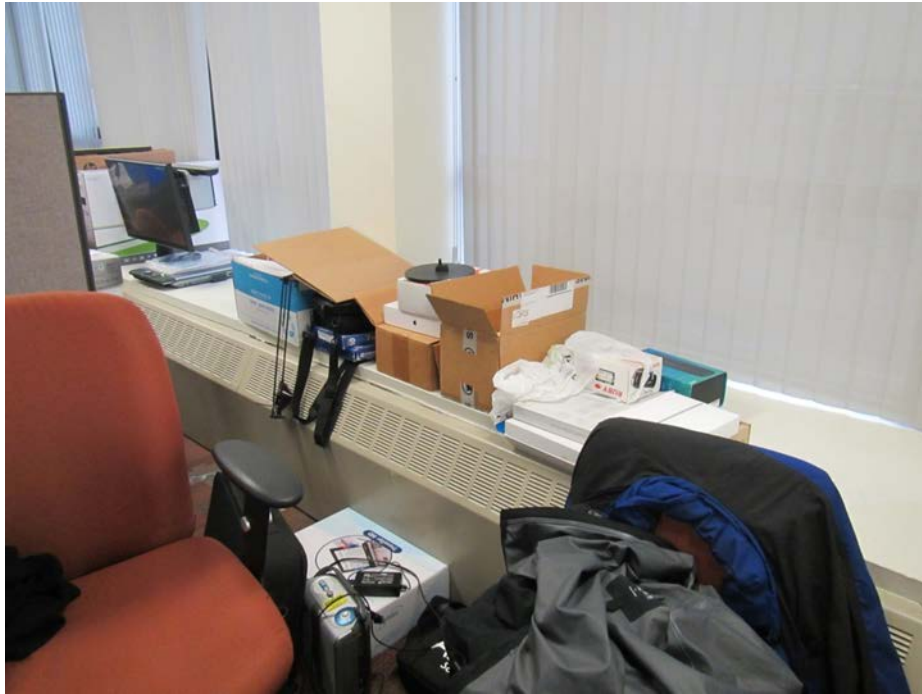
Picture 14

Items on radiator

1. Operate supply and exhaust ventilation continuously in all areas during occupied periods. Ensure all HVAC equipment is cleaned/maintained in accordance with manufacturer's instructions. Avoid piling items on top of radiators
2. Have the HVAC system balanced every 5 years in accordance with SMACNA recommendations (SMACNA, 1994). Consider a rebalancing when the building layout is changed.
3. Use adjustable blinds to control solar heating and glare.
